PERIODIC REVIEW

**American Avionics
Facility Site ID#: 39659753**

**7023 Perimeter Road South,
Seattle, Washington**

March 2010

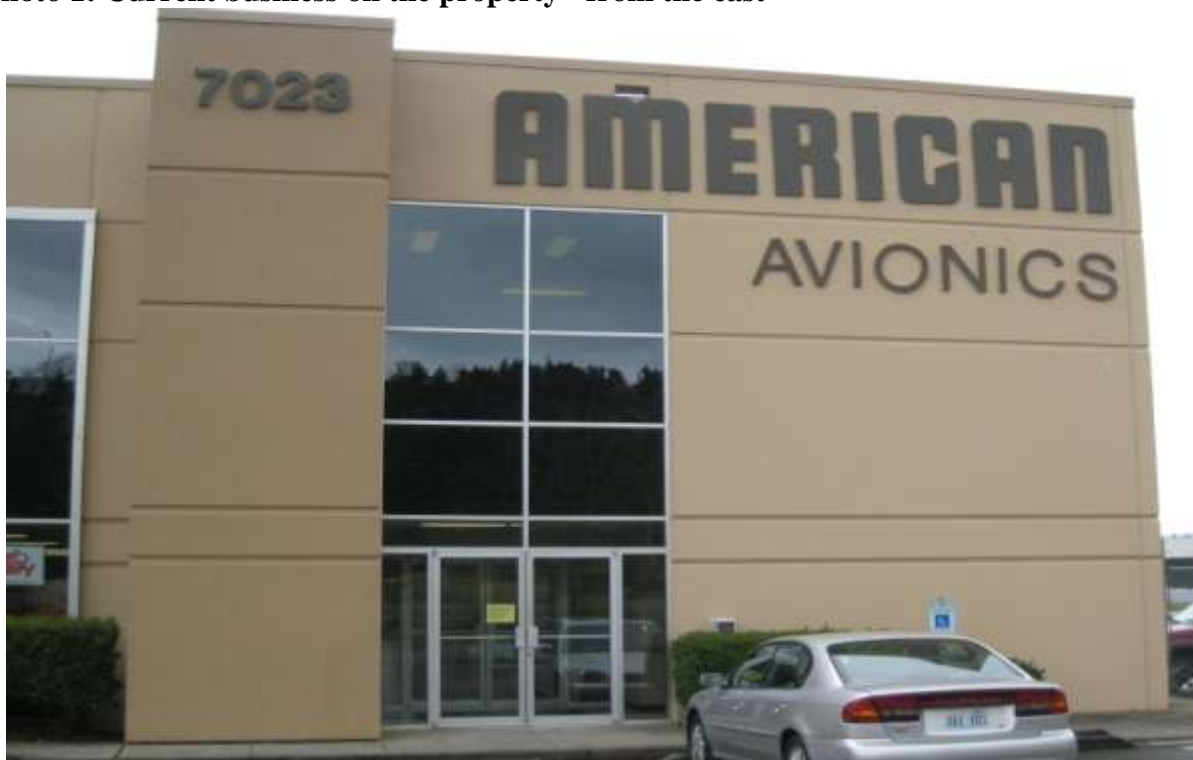
Photo 1: Current business on the property - from the east

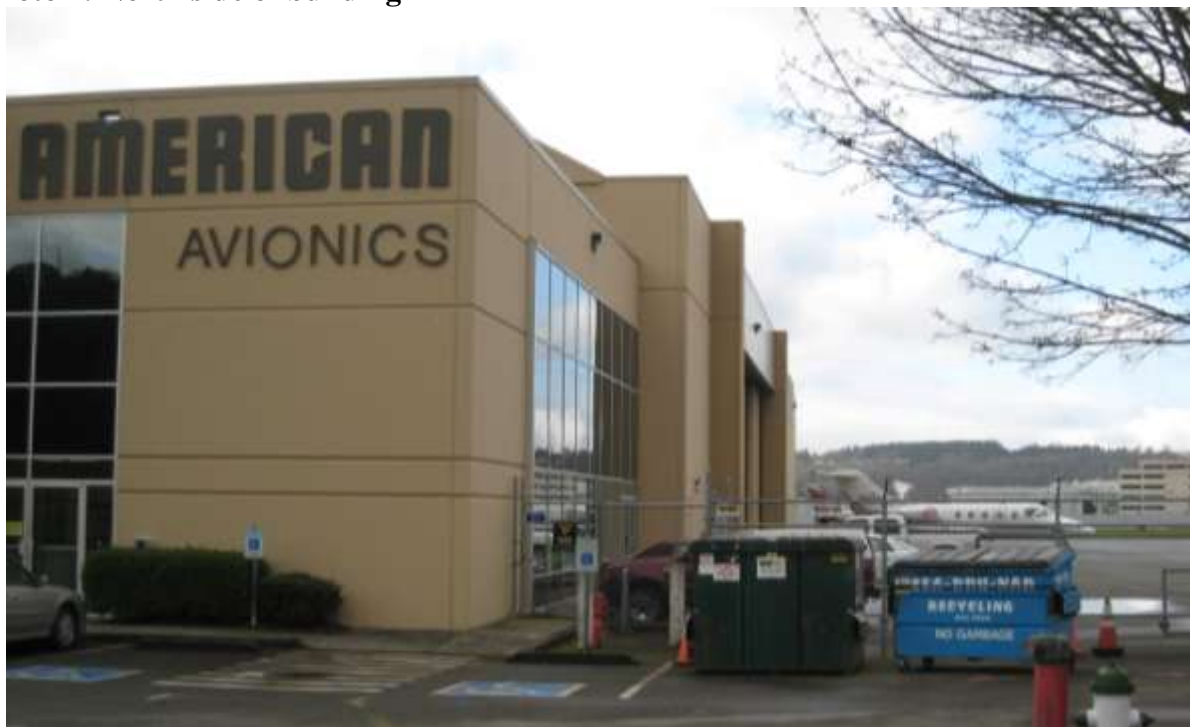
Photo 2: North side of building

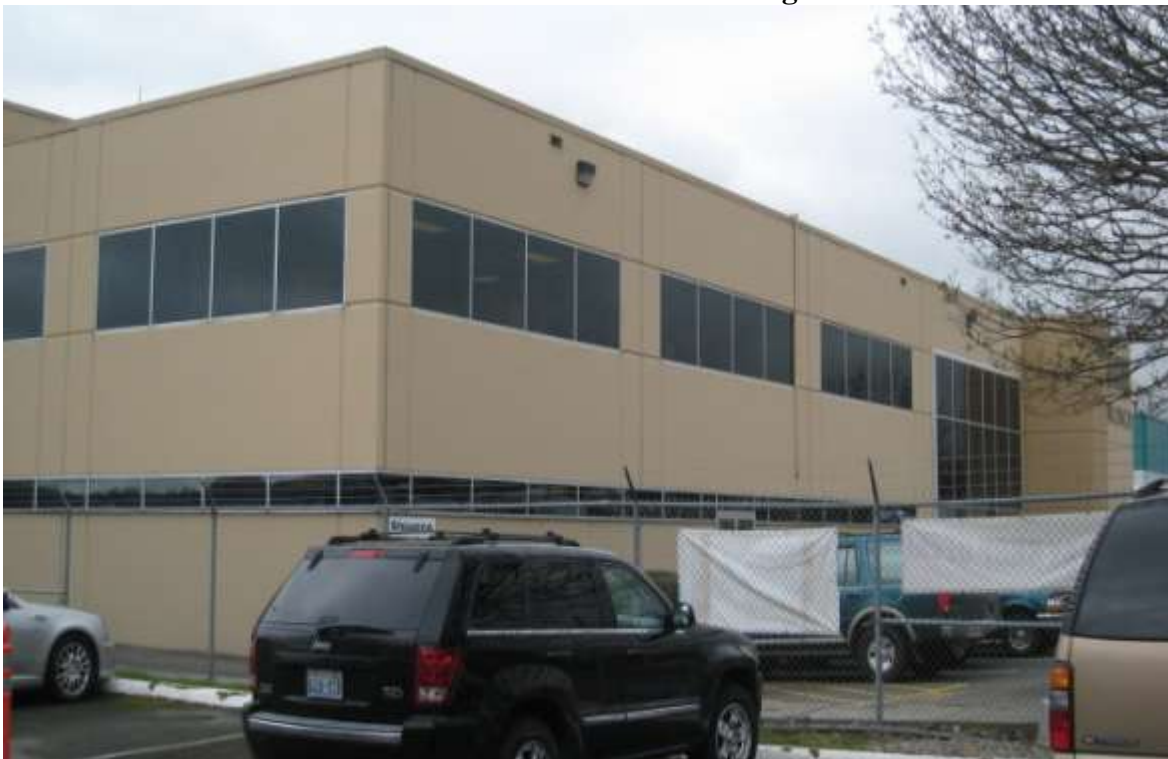
Photo 3: Southeast corner of the American Avionics building

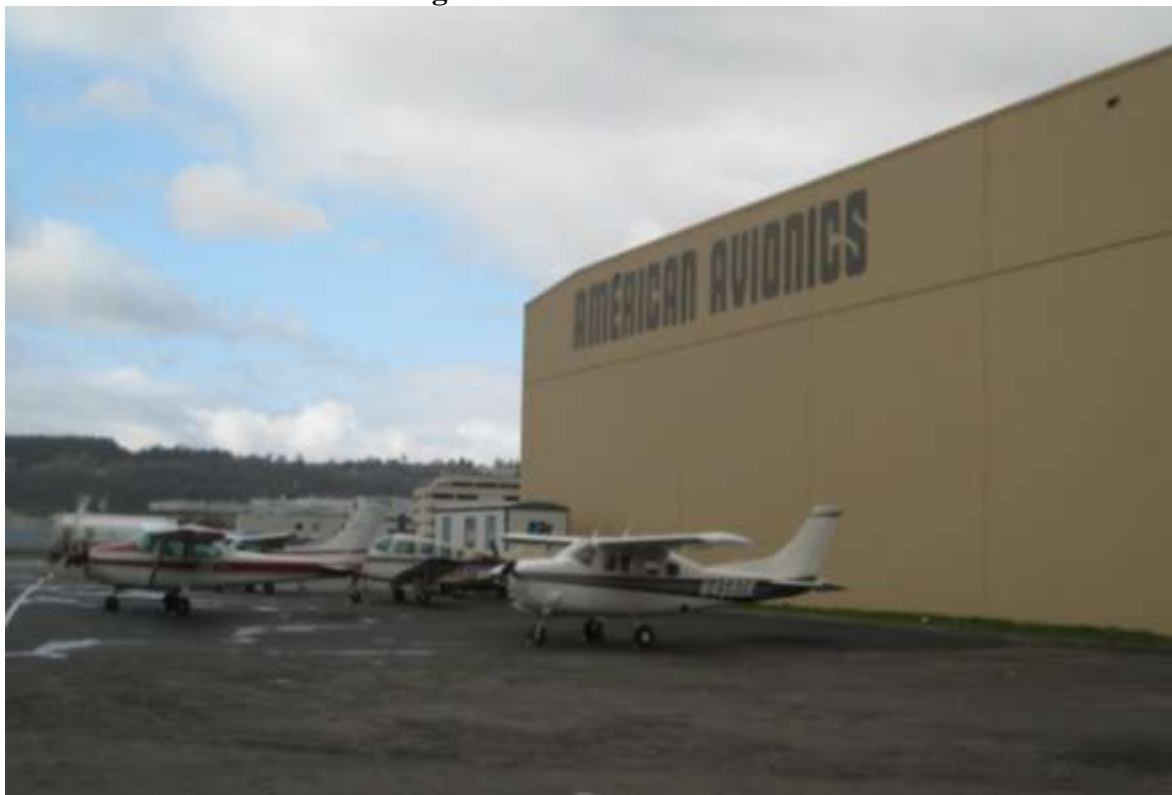
Photo 4: South Side of the building
